TEST #14

IFI 9 Gauge 2" Weave Chain Link Fence | One-person cut through utilizing wire cutters

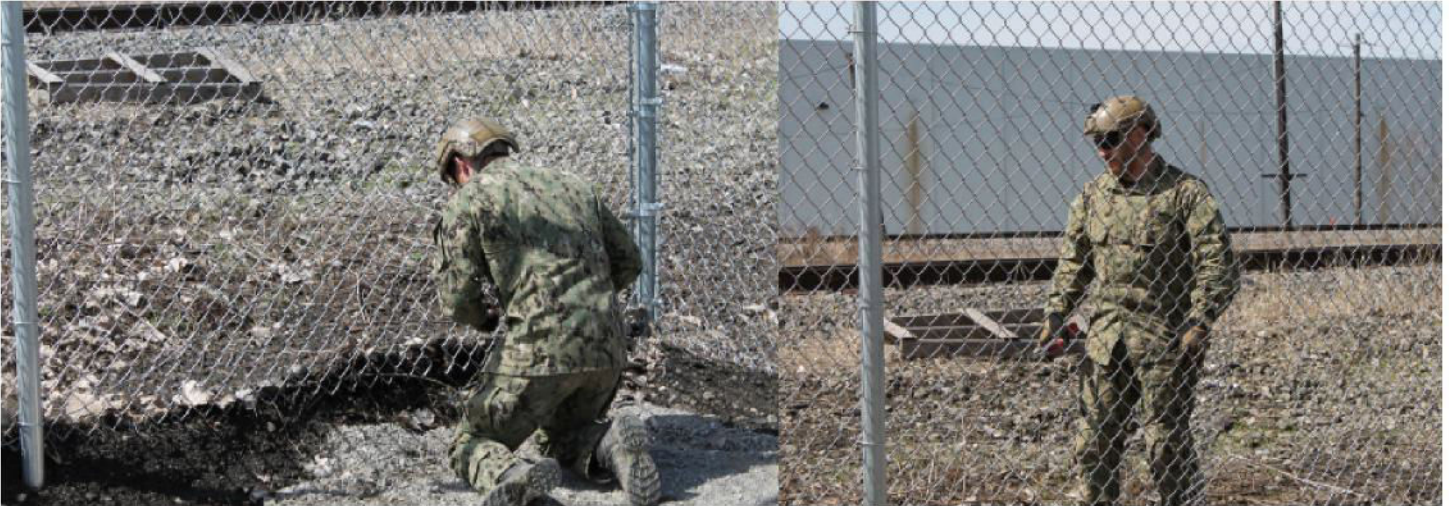
Description: This was a one-person test utilizing off-the-shelf wire cutters to penetrate the chain link fence in a straight, vertical line. Time was started when the person began to cut the fence and stopped when the person successfully climbed through to the other side of the fence.

Results: Successful penetration in 31 seconds.

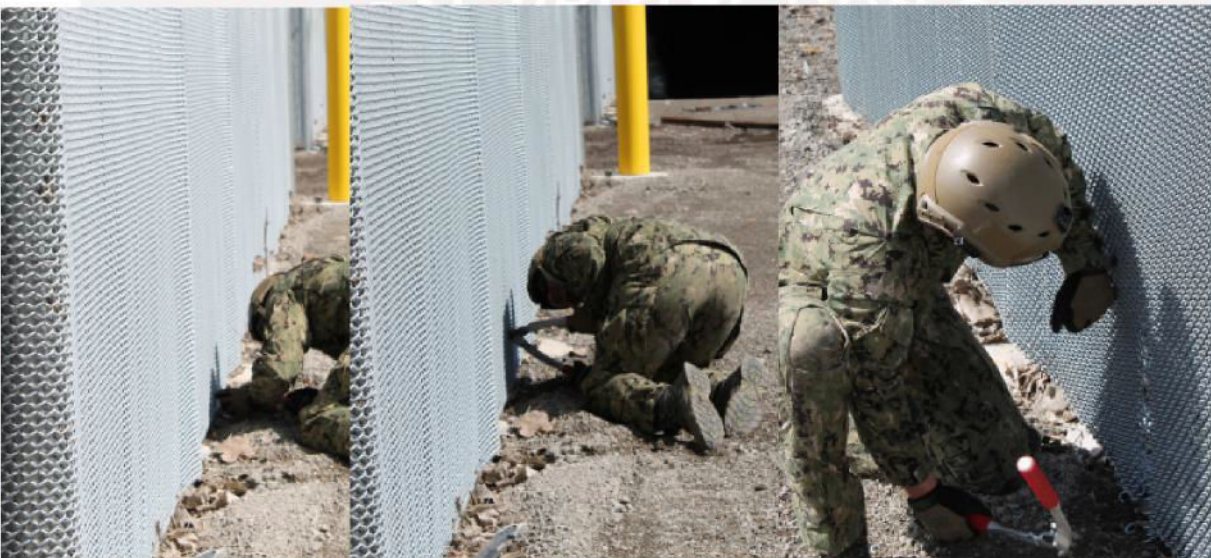
TEST #15

IFI-6 Extreme Cut 6 Gauge 5/8" Weave Chain Link | one person cut-through utilizing wire cutters

Description: This test involved one person utilizing wire cutters to breach the chain link weave fence. The attacker cut down a straight line to allow passage to the other side of the fence. The test started when the tool first touched the fence and ended when the attacker breached to the other side. Results: Successful penetration in 6 minutes and 49 seconds.

Issue(s): The nature of the wire weave meant that successfully cut pieces provided an additional, continuing impediment to the attack.

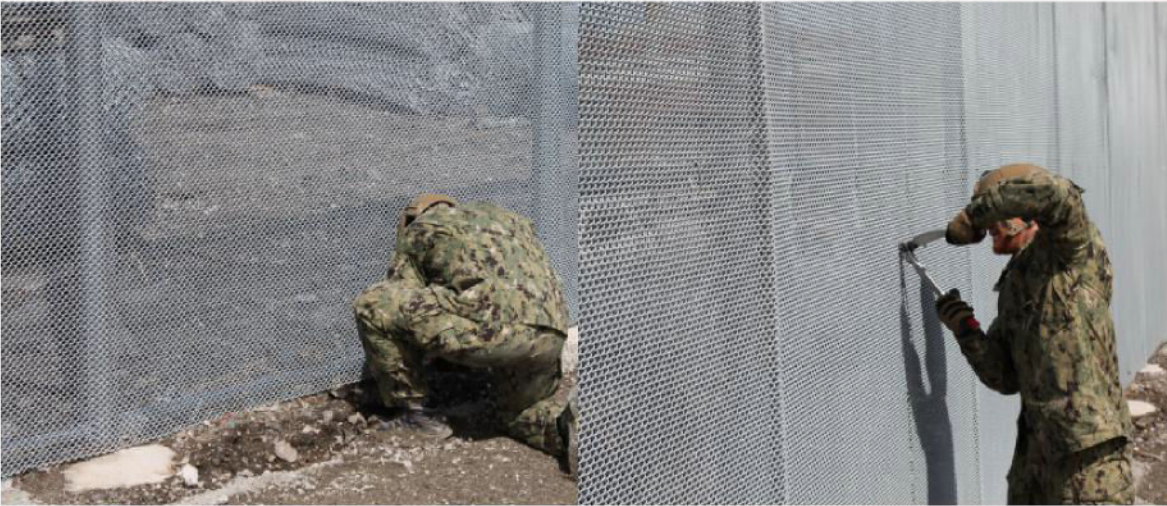
TEST #19

9 Gauge 3/8" Weave Chain Link | One-person attack utilizing wire cutters

Description: This was a one-person attack utilizing off-the-shelf wire cutters to penetrate 9 gauge 3/8" weave fence. The attacker cut a vertical line through the fence, eventually allowing successful pass-through. The test started when the attacker placed the wire cutters on the fence and ended when successful breach occurred to the other side.

Results: Breach of fence in 4 minutes 32 seconds.

Issue(s): Cut pieces of weave fence provided additional impediment to breach.

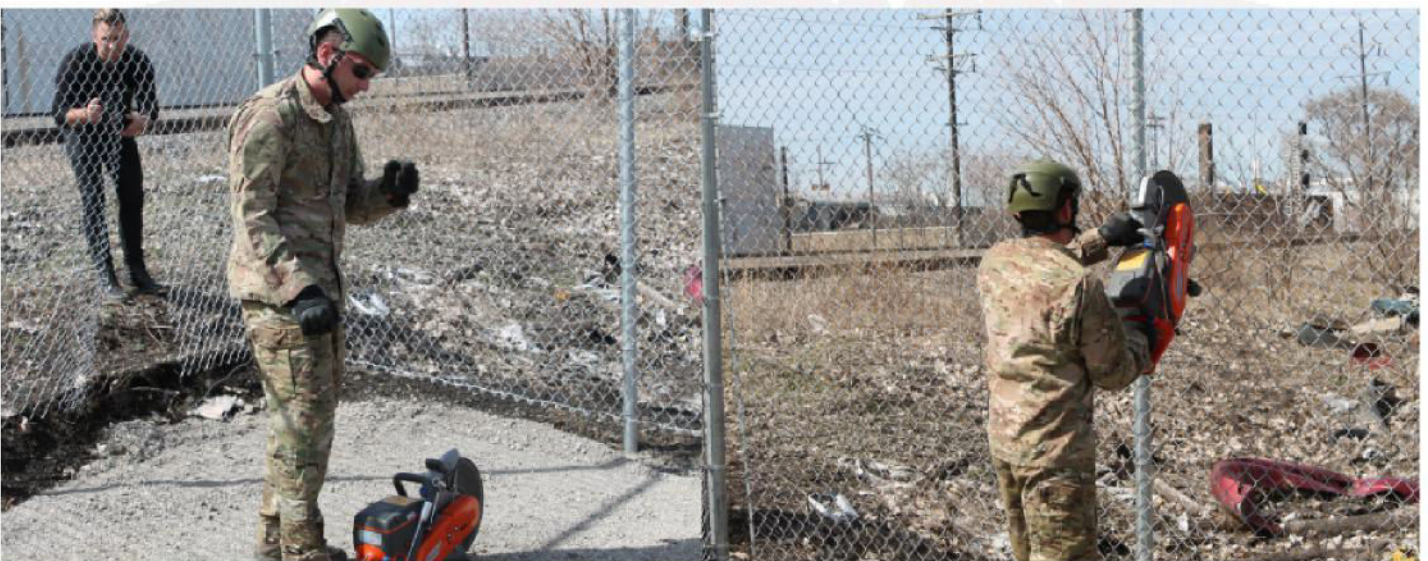
TEST #20

IFI 9 Gauge 2" Weave Chain Link | One person cut-through utilizing gas powered "Quickie" saw

Description: This test involved one person utilizing a gas powered saw to cut a vertical entrance in the fence. The test started when the saw touched the fence and ended when the attacker was successfully through the barrier.

Results: Successful breach in 19 seconds

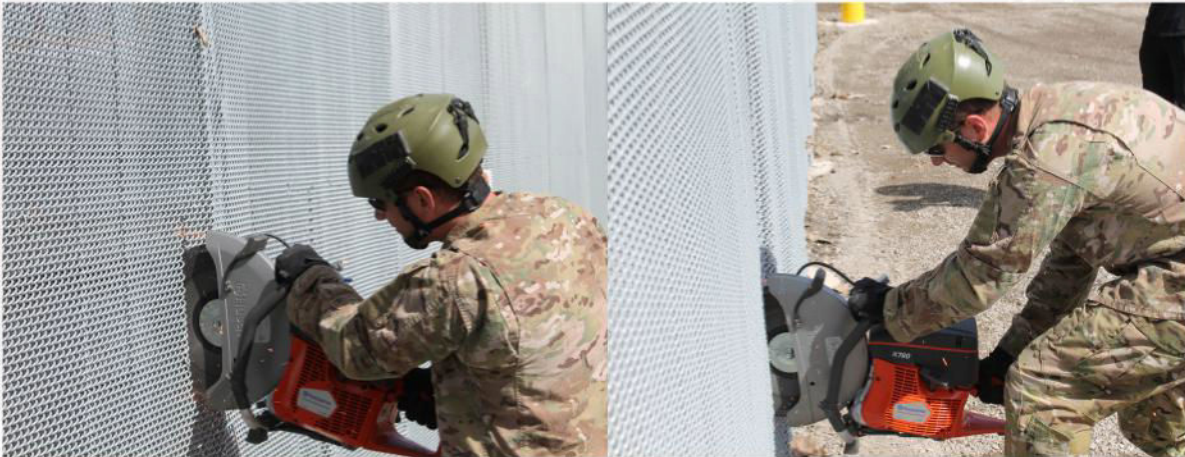
TEST #21

IFI-6 Extreme Cut 6 Gauge 5/8" Weave Chain Link | One-person cut-through with gas powered "Quickie" saw

Description: This test involved one-person cutting through 6 Gauge 5/8" weave chain link fence with a gas powered saw. The attacker cut down in a vertical line, creating an opening that allowed a successful breach. The test started when the saw first touched the fence and ended when the attacker was successfully through to the other side.

Results: Successful cut-through that took 41 seconds.

Observation: The saw did not produce the same cut links that provided additional impediment using hand tools.

Issue(s): The gas powered cut-off saw was very loud and caused sparks and smoke that may be detected by security cameras.

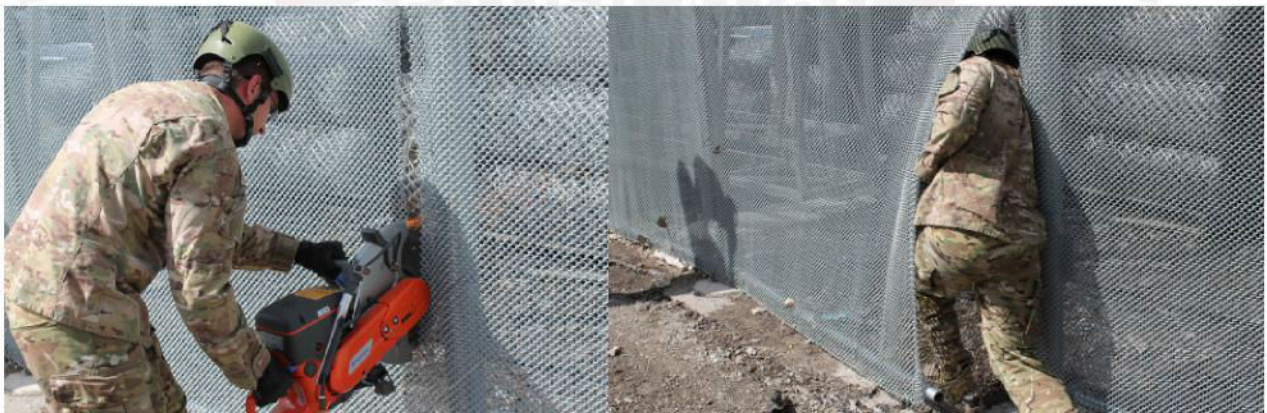
TEST #22

IFI 9 Gauge 3/8" Weave Chain Link | One-person cut-through utilizing gas powered "Quickie" saw

Description: This test involved one attacker and a gas powered saw. The attacker cut a vertical opening in the mesh fence large enough to allow passage of a person through to the other side. The test started when the saw first touched the fence and ended when the attacker was successfully through to the other side.

Results: Successful cut-through in 38 seconds.

Issue(s): The gas powered cut-off saw was very loud and caused sparks and smoke that may be detected by security cameras.

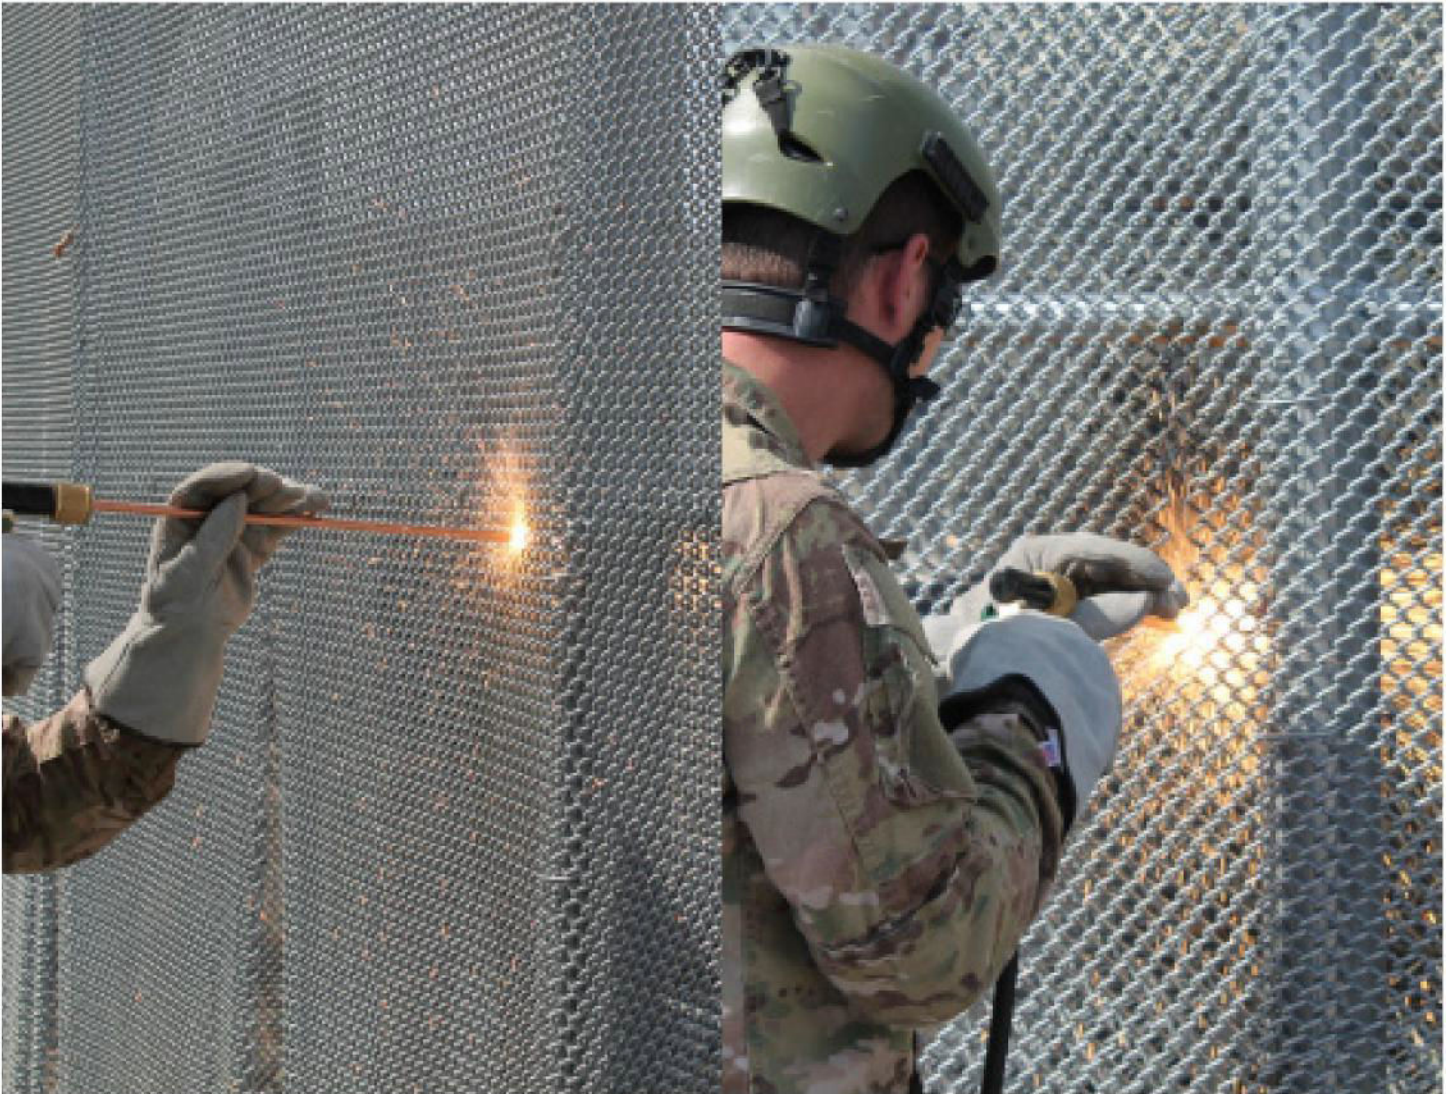
TEST #26

9 Gauge 2" Weave Chain Link | One-person Broco Torch attack

Description: This was a one-person attack utilizing a Broco Torch against a 9 gauge chain link fence. Although this is considered a one-person test, an assistant did provide extra torch rods when spent, and poured water on the fence to cool it after successful penetration. The attacker used the torch to create a vertical opening in the fence. The test started after the torch was lit and ended when the attacker successfully climbed through to the other side.

Results: Successful breach in 1 minute and 26 seconds.

Issue(s): Broco Torch produces a large amount of highly visible sparks and smoke, likely detectable by security cameras or people in proximity to the tool being used.
