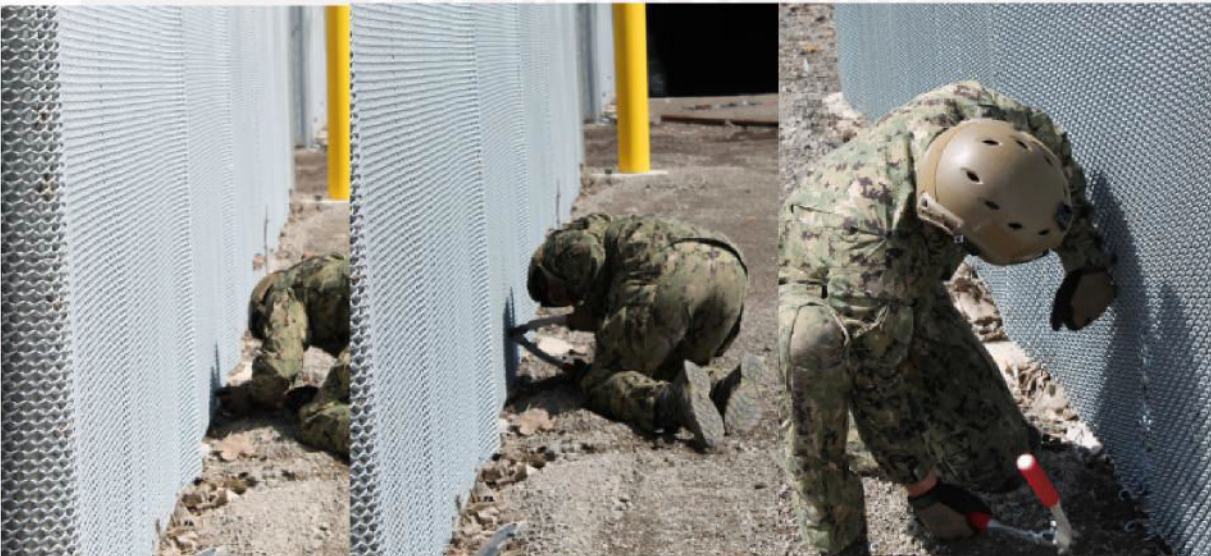
TEST #15

IFI-6 Extreme Cut 6 Gauge 5/8" Weave Chain Link | one person cut-through utilizing wire cutters

Description: This test involved one person utilizing wire cutters to breach the chain link weave fence. The attacker cut down a straight line to allow passage to the other side of the fence. The test started when the tool first touched the fence and ended when the attacker breached to the other side. Results: Successful penetration in 6 minutes and 49 seconds.

Issue(s): The nature of the wire weave meant that successfully cut pieces provided an additional, continuing impediment to the attack.
