SECTION II: TESTS AND RESULTS

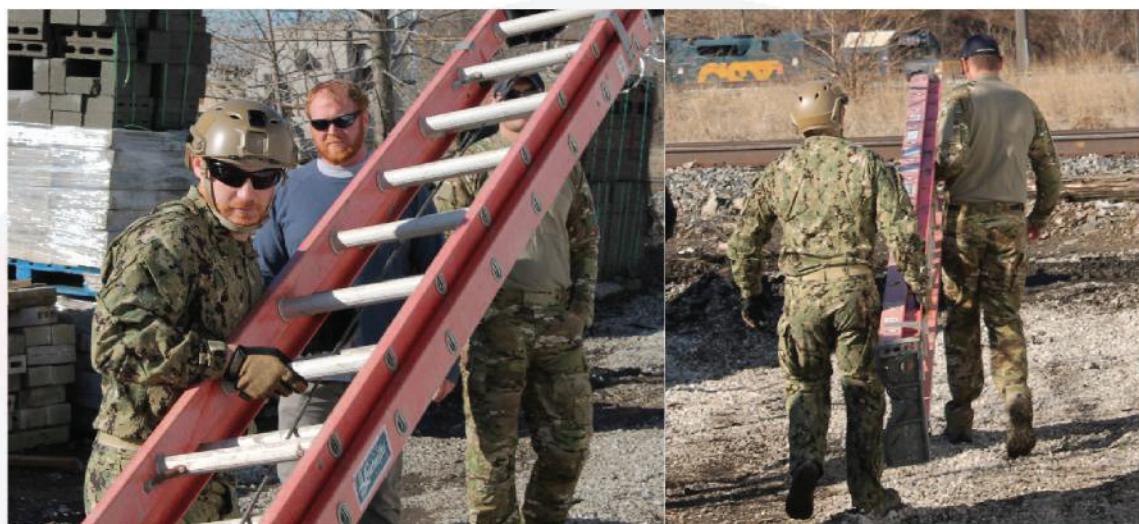
TEST #1

IFI-12 Mini Louver Barrier System with Barbed Wire | One-person climb-over utilizing a ladder

Description: This test involved one person climbing over the 12' IFI-12 Mini Louver type fence with a ladder. Time began when the person started to move forward and stopped when the person touched the ground on the other side of the fence.

Results: Successful climb-over that took 18 seconds.

Issue(s): Ladder was bulky and awkward to carry while running.

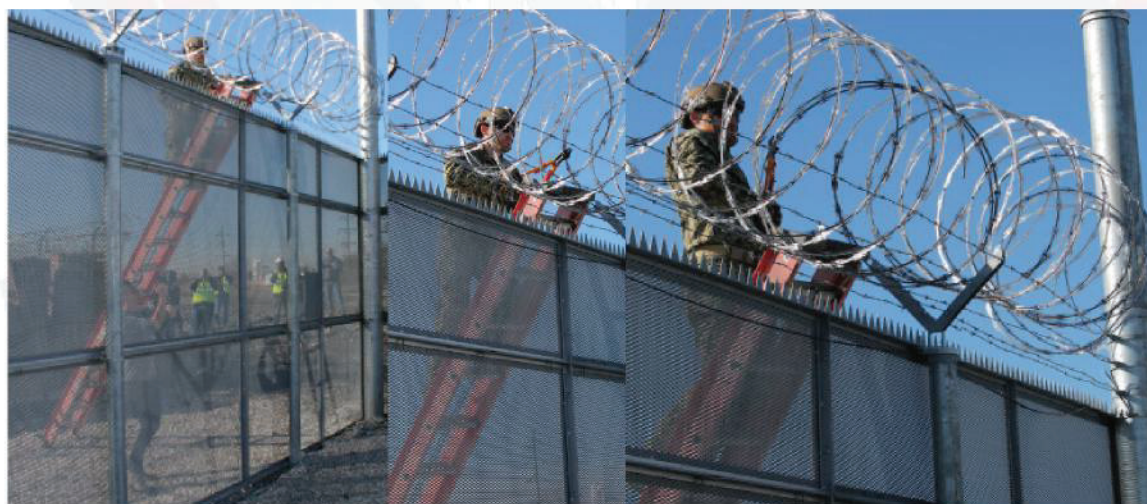
TEST #2

IFI-12 Mini Louver Barrier System with Razor Wire | One-person climb-over utilizing a ladder and bolt cutters

Description: This test involved one person climbing over the 12' IFI-12 Mini Louver type fence with a ladder and bolt cutters to clear the mounted razor wire. Time began when the person started to move forward and stopped when the person touched the ground on the other side of the fence.

Results: Successful climb-over that took 57seconds.

Issue(s): Razor wire provided significant increase in breach time.
