SECTION II: TESTS AND RESULTS

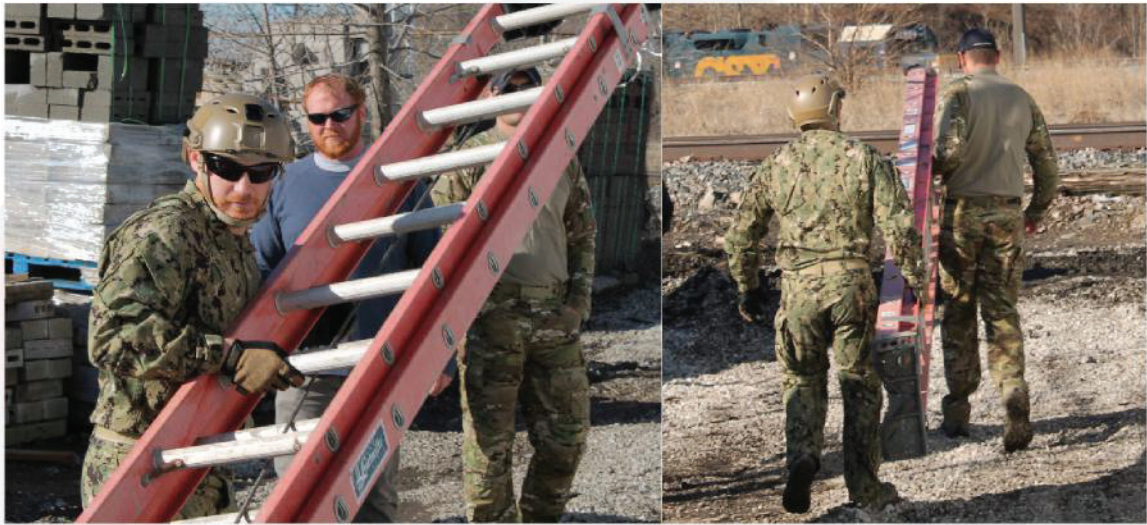
TEST #1

IFI-12 Mini Louver Barrier System with Barbed Wire | One-person climb-over utilizing a ladder
 Description: This test involved one person climbing over the 12' IFI-12 Mini Louver type fence with a ladder. Time began when the person started to move forward and stopped when the person touched the ground on the other side of the fence.

Results: Successful climb-over that took 18 seconds.
 Issue(s): Ladder was bulky and awkward to carry while running.

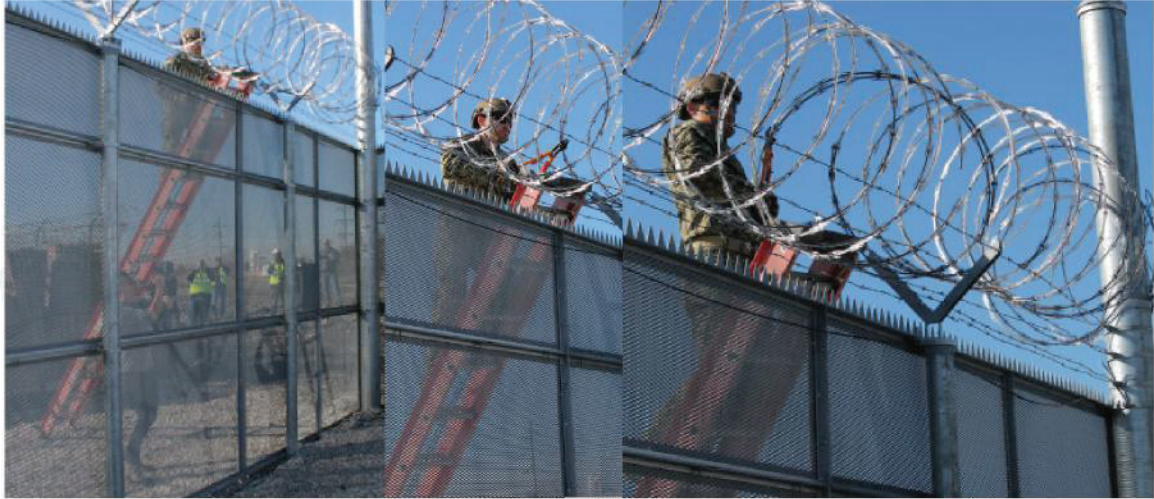
TEST #2

IFI-12 Mini Louver Barrier System with Razor Wire | One-person climb-over utilizing a ladder and bolt cutters
 Description: This test involved one person climbing over the 12' IFI-12 Mini Louver type fence with a ladder and bolt cutters to clear the mounted razor wire. Time began when the person started to move forward and stopped when the person touched the ground on the other side of the fence.

Results: Successful climb-over that took 57seconds.
 Issue(s): Razor wire provided significant increase in breach time.

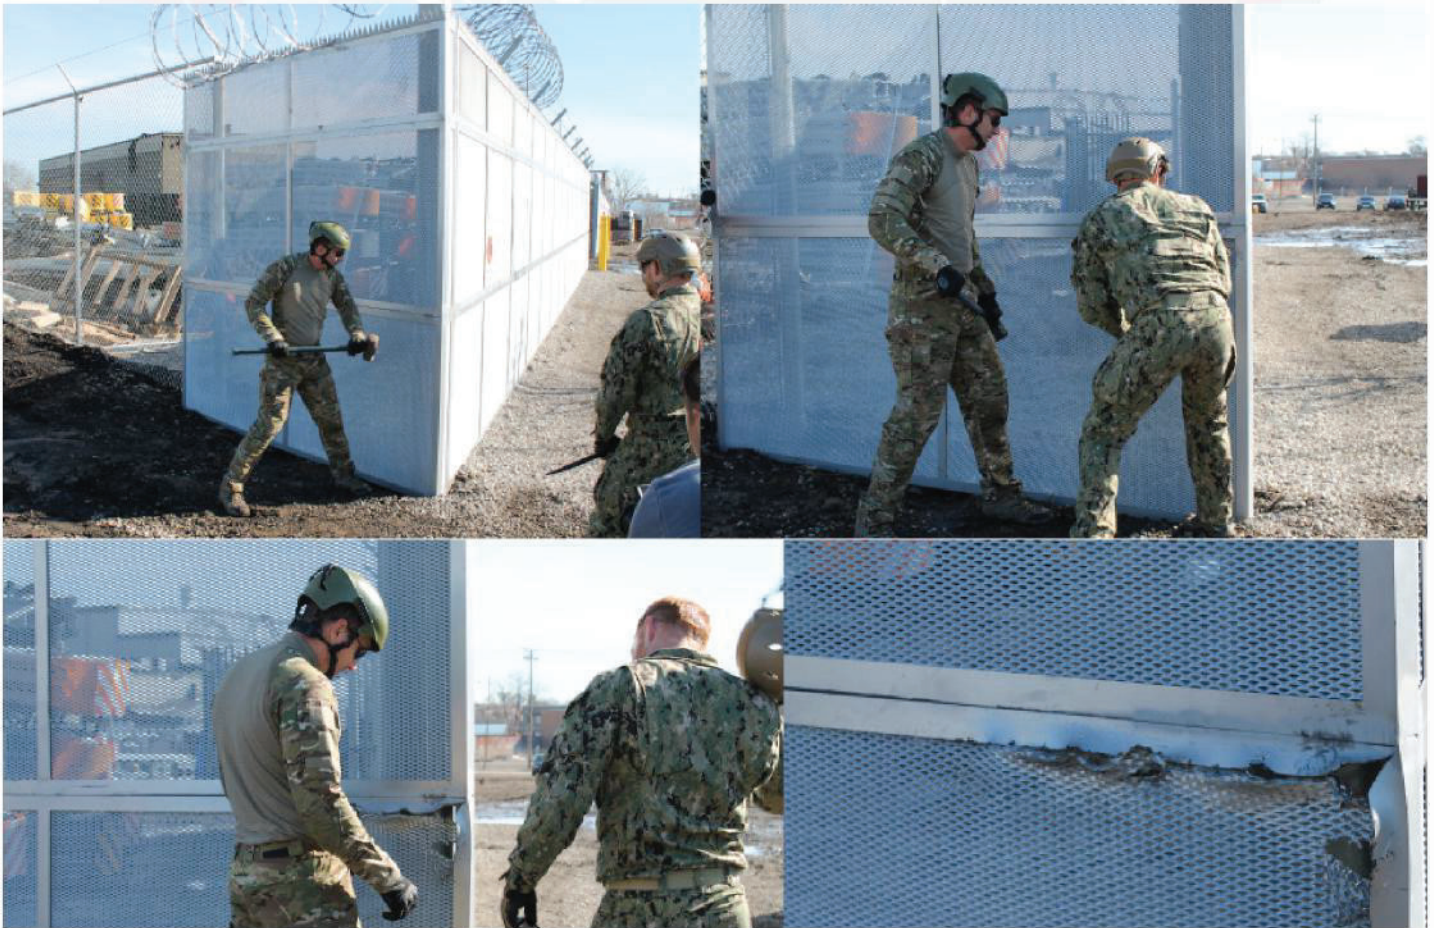
TEST #4

12' IFI-12 Mini Louver Barrier System Corner Test | Two-person attack with hand tools

Description: This was a two-person test; each taking turns with a sledge hammer and pry bar in order to defeat the corner of the barrier. Time began with first strike of hammer and ended after 15 minutes with both attackers unable to penetrate the fence.

Results: Team was not able to breach corner within 15 minute allotted time limit.

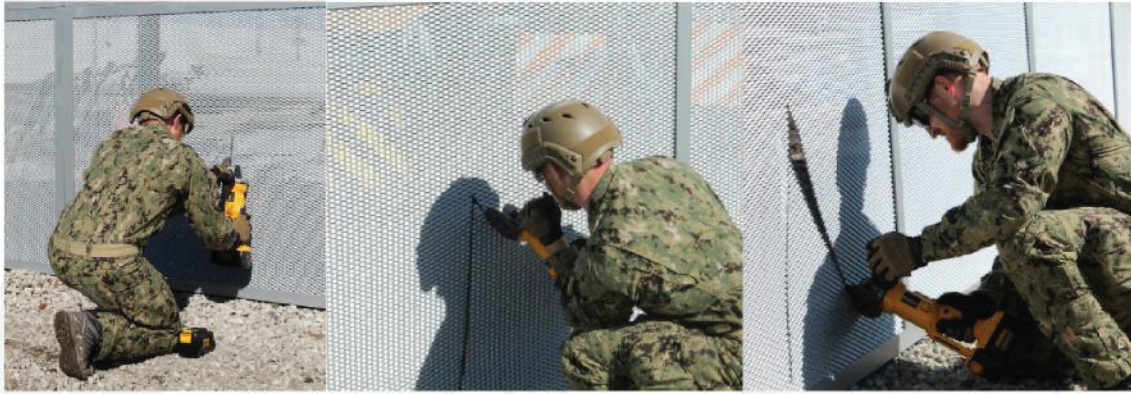
TEST #5

IFI-12 Mini Louver Barrier System | One-person attack with 36V battery operated grinder

Description: This test involved one person cutting through the face of the 12' IFI-12 Mini Louver fence with a battery powered grinder. A triangular shaped incision was made, and the wall of the fence was folded downward to create an opening. Time began when the person put the grinder to the fence and ended after said person breached through to the other side of the barrier.

Results: Successful penetration that took 7 minutes and 47 seconds.

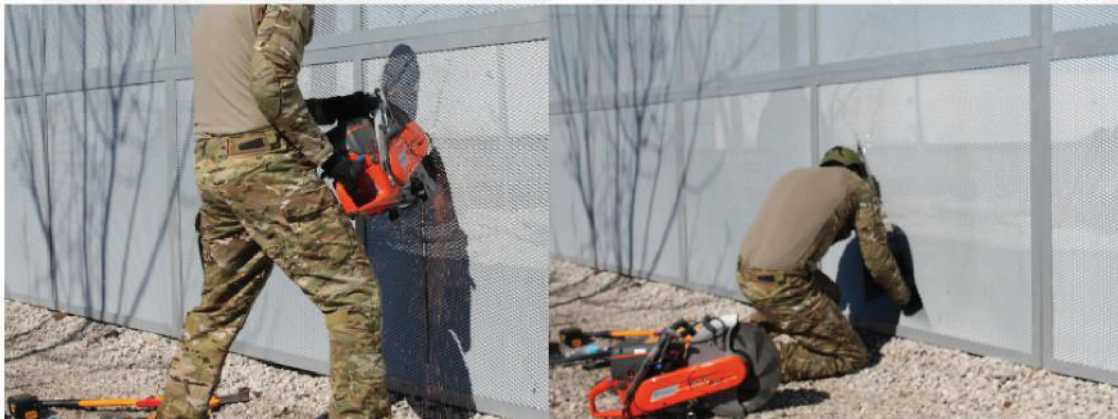
TEST #6

12' IFI-12 Mini Louver Barrier System | One-person cut-through with gas powered "Quickie" demolition saw

Description: This was a one-person test utilizing a gas powered demolition saw. One person used the saw to create a triangular cut large enough for a person to enter. The time was started when the saw was placed against the fence panel and stopped when one person successfully crawled through to the other side of the fence.

Results: Successful penetration and crawl-through that took 1 minute and 30 seconds.

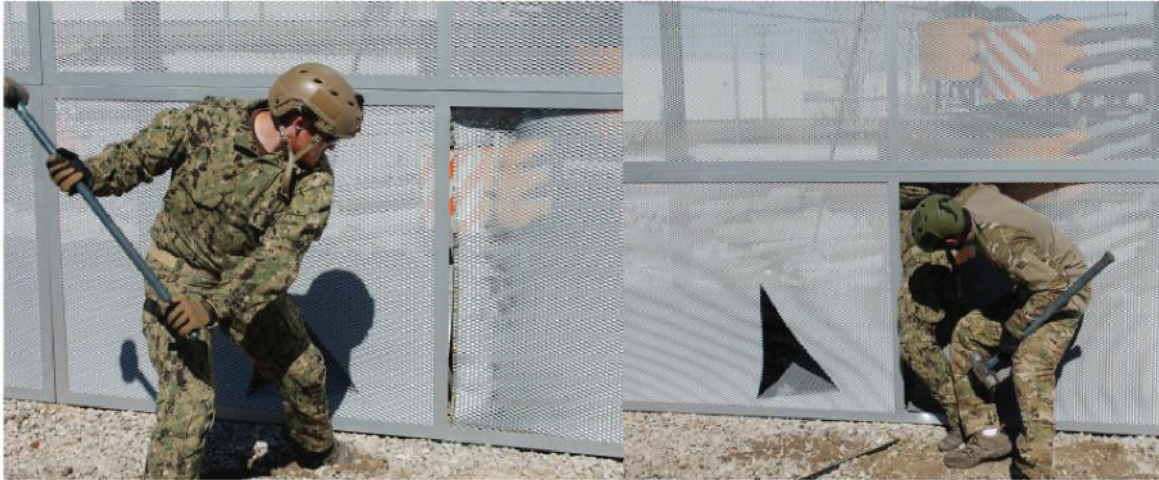
TEST #7

12' IFI-12 Mini Louver Barrier System | Two-person attack with hand tools

Description: This test involved two people attacking the side panel of the fence with hand tools, including a sledge hammer, pry bar, and bolt-cutters. Time started when the first strike against the fence was made and stopped when one person crawled through to the other side.

Results: Successful penetration that took 3 minutes and 17 seconds.
