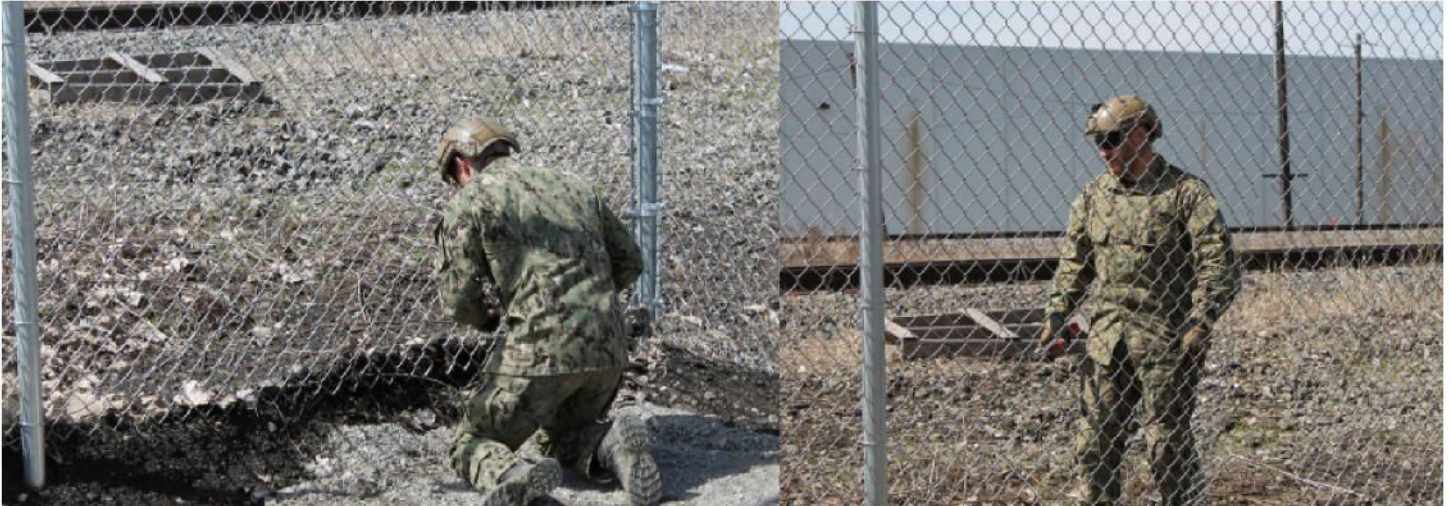
TEST #14

IFI 9 Gauge 2" Weave Chain Link Fence | One-person cut through utilizing wire cutters

Description: This was a one-person test utilizing off-the-shelf wire cutters to penetrate the chain link fence in a straight, vertical line. Time was started when the person began to cut the fence and stopped when the person successfully climbed through to the other side of the fence.

Results: Successful penetration in 31 seconds.

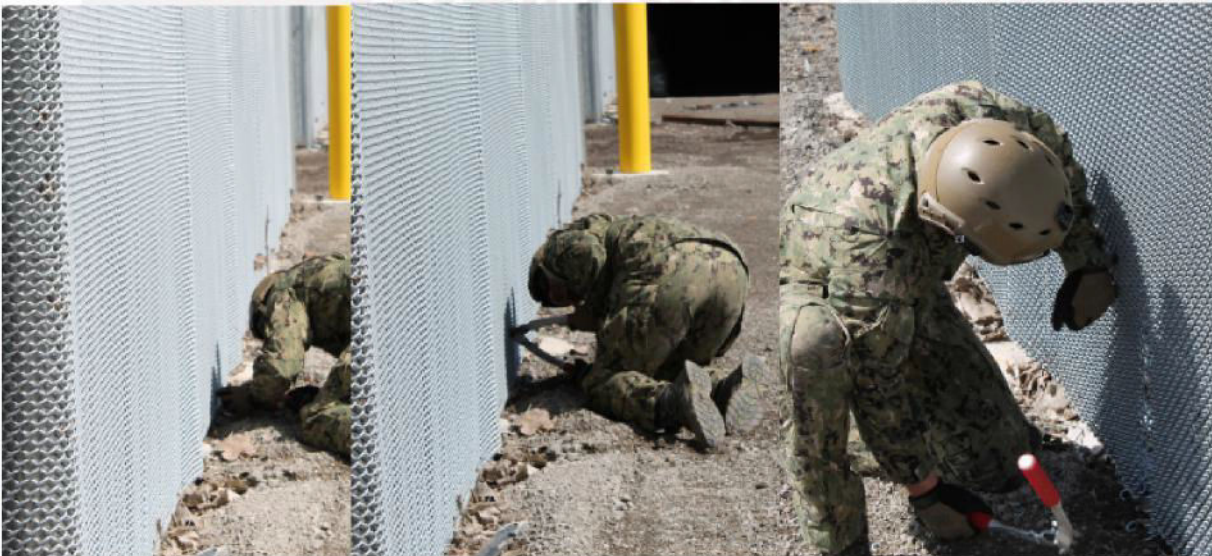
TEST #15

IFI-6 Extreme Cut 6 Gauge 5/8" Weave Chain Link | one person cut-through utilizing wire cutters

Description: This test involved one person utilizing wire cutters to breach the chain link weave fence. The attacker cut down a straight line to allow passage to the other side of the fence. The test started when the tool first touched the fence and ended when the attacker breached to the other side. Results: Successful penetration in 6 minutes and 49 seconds.

Issue(s): The nature of the wire weave meant that successfully cut pieces provided an additional, continuing impediment to the attack.

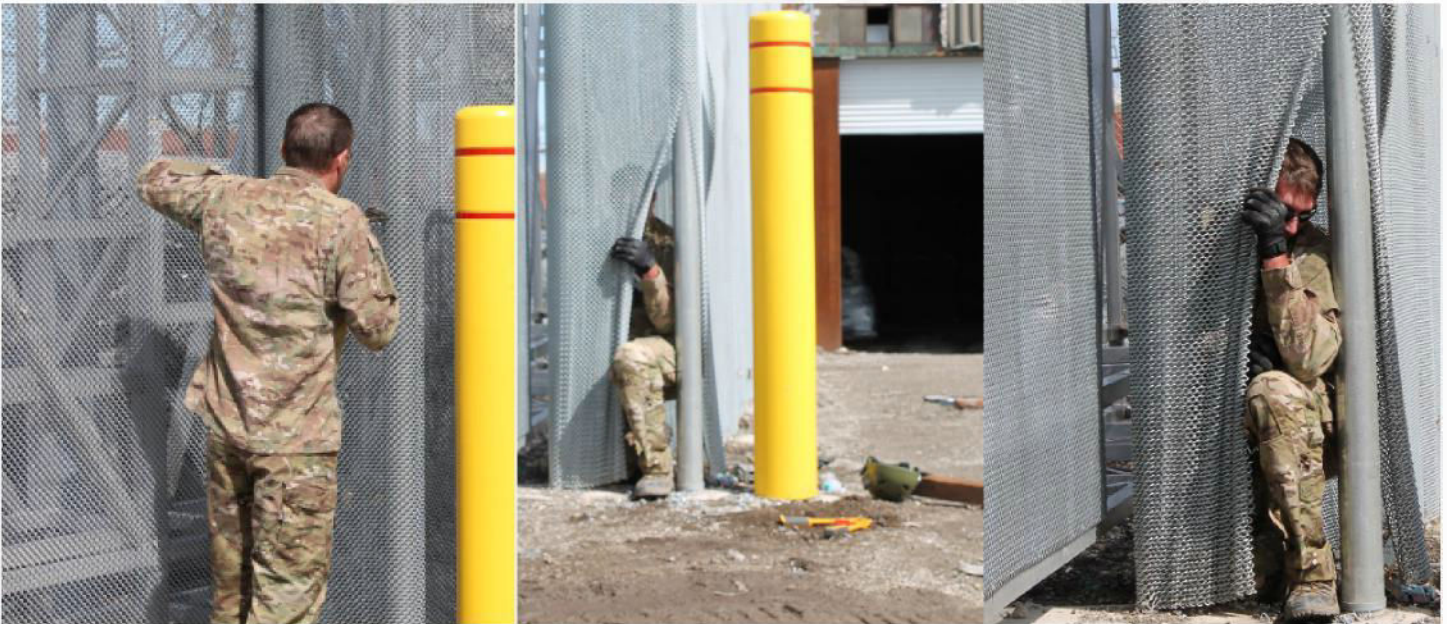
TEST #18

IFI 9 Gauge 3/8" Weave Chain Link Corner | One-person cut-through with bolt cutters

Description: This was a one-person test utilizing bolt cutters to penetrate through the 9 Gauge weave fence wrapped around a corner post. The attacker cut in a vertical line to allow entry to the other side of the fence. The test started when the bolt cutters were placed on the fence and stopped when the fence was successfully breached by the attacker.

Results: Successful breach in 2 minutes and 47 seconds

Issue(s): Cut pieces of weave fence provided additional impediment to breach.

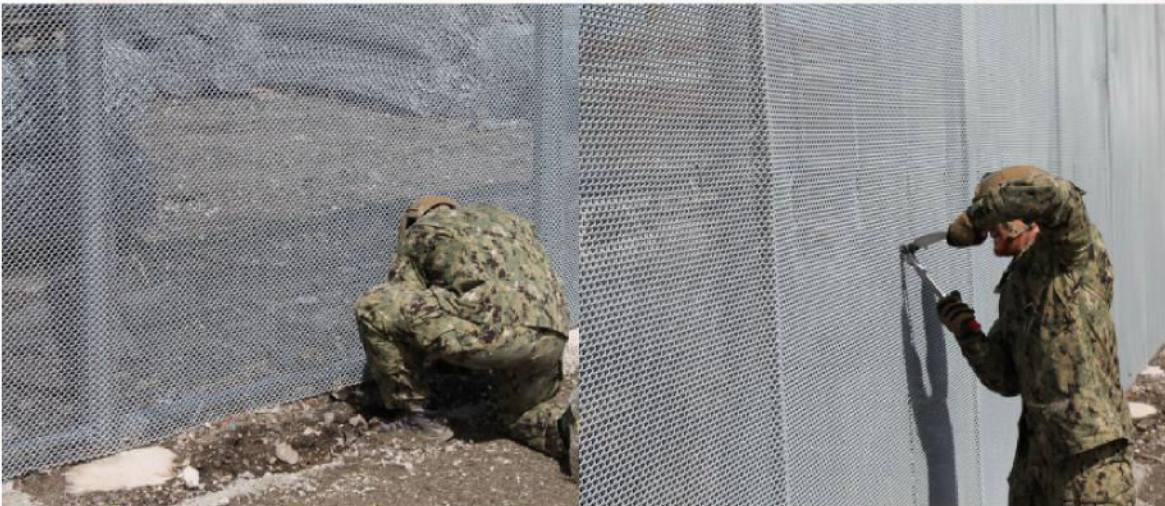
TEST #19

9 Gauge 3/8" Weave Chain Link | One-person attack utilizing wire cutters

Description: This was a one-person attack utilizing off-the-shelf wire cutters to penetrate 9 gauge 3/8" weave fence. The attacker cut a vertical line through the fence, eventually allowing successful pass-through. The test started when the attacker placed the wire cutters on the fence and ended when successful breach occurred to the other side.

Results: Breach of fence in 4 minutes 32 seconds.

Issue(s): Cut pieces of weave fence provided additional impediment to breach.

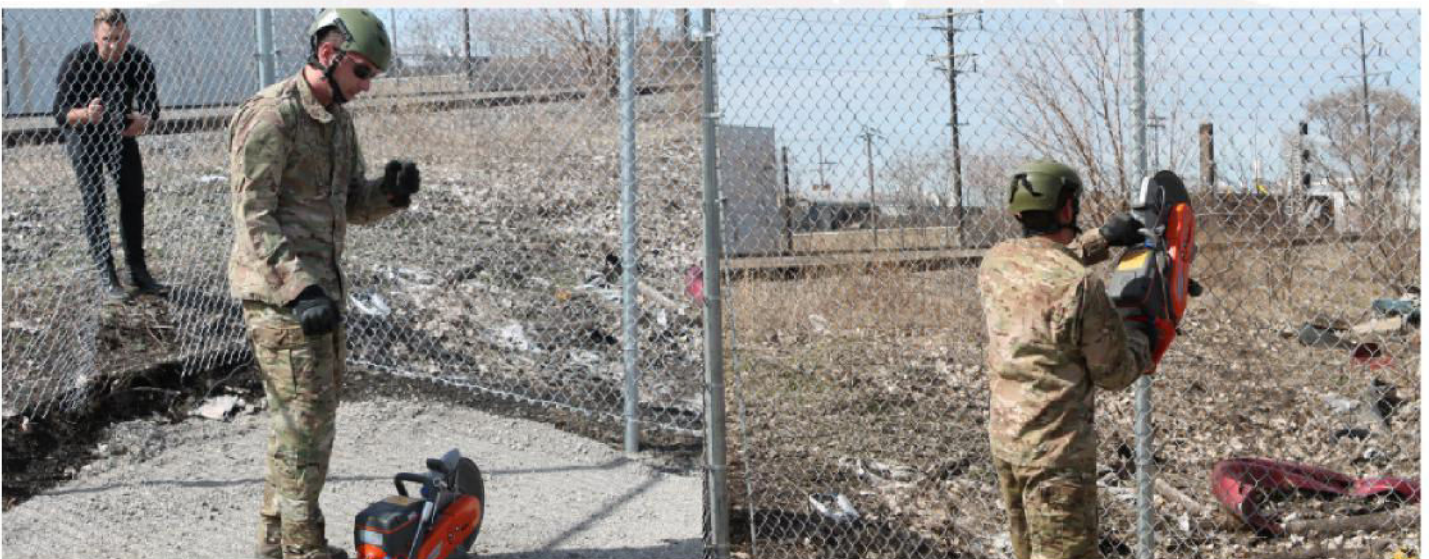
TEST #20

IFI 9 Gauge 2" Weave Chain Link | One person cut-through utilizing gas powered "Quickie" saw

Description: This test involved one person utilizing a gas powered saw to cut a vertical entrance in the fence. The test started when the saw touched the fence and ended when the attacker was successfully through the barrier.

Results: Successful breach in 19 seconds

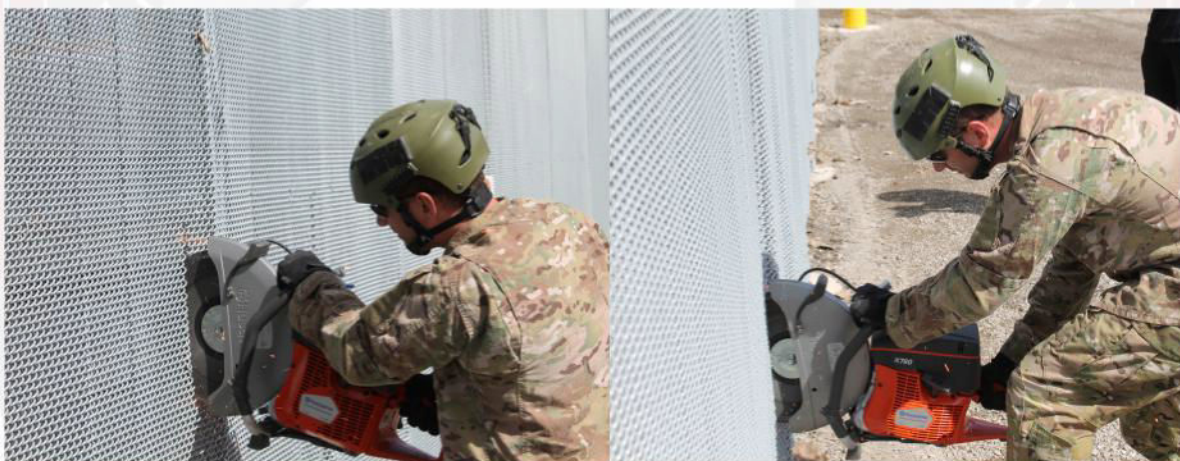
TEST #21

IFI-6 Extreme Cut 6 Gauge 5/8" Weave Chain Link | One-person cut-through with gas powered "Quickie" saw

Description: This test involved one-person cutting through 6 Gauge 5/8" weave chain link fence with a gas powered saw. The attacker cut down in a vertical line, creating an opening that allowed a successful breach. The test started when the saw first touched the fence and ended when the attacker was successfully through to the other side.

Results: Successful cut-through that took 41 seconds.

Observation: The saw did not produce the same cut links that provided additional impediment using hand tools.

Issue(s): The gas powered cut-off saw was very loud and caused sparks and smoke that may be detected by security cameras.

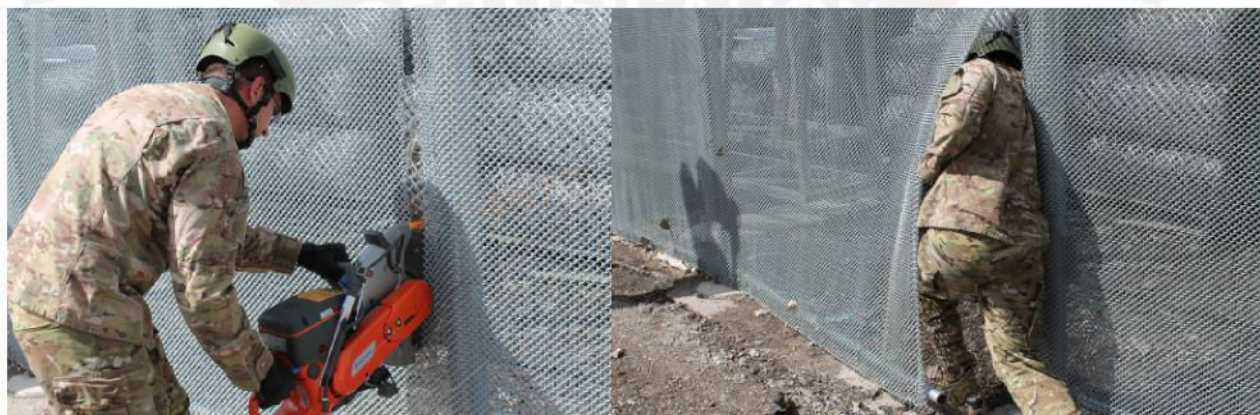
TEST #22

IFI 9 Gauge 3/8" Weave Chain Link | One-person cut-through utilizing gas powered "Quickie" saw

Description: This test involved one attacker and a gas powered saw. The attacker cut a vertical opening in the mesh fence large enough to allow passage of a person through to the other side. The test started when the saw first touched the fence and ended when the attacker was successfully through to the other side.

Results: Successful cut-through in 38 seconds.

Issue(s): The gas powered cut-off saw was very loud and caused sparks and smoke that may be detected by security cameras.

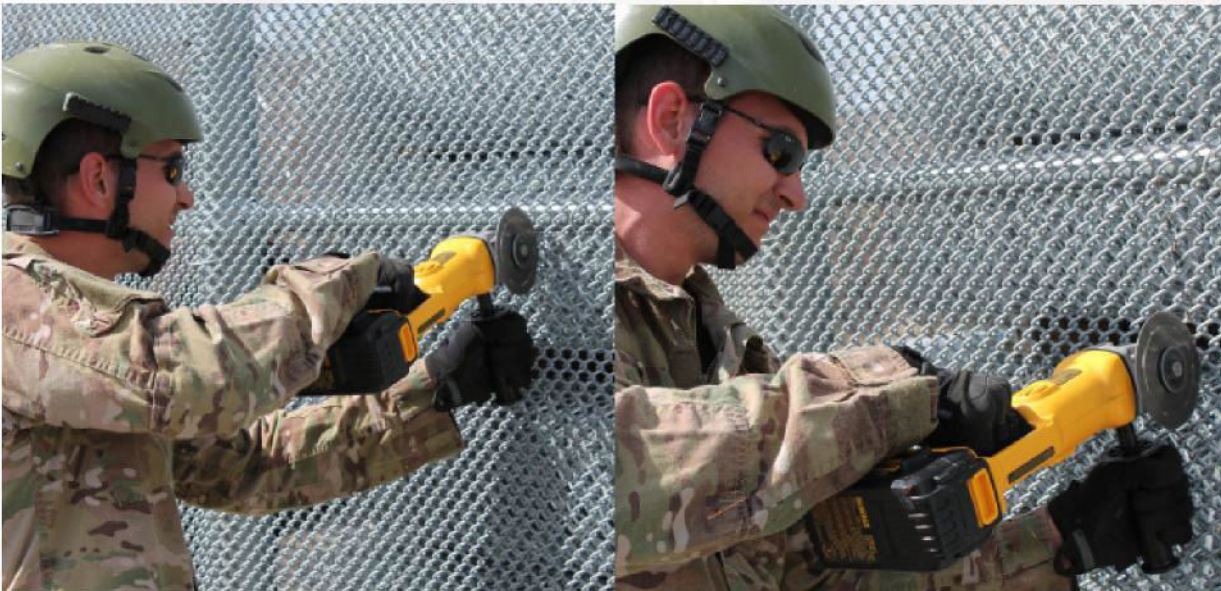
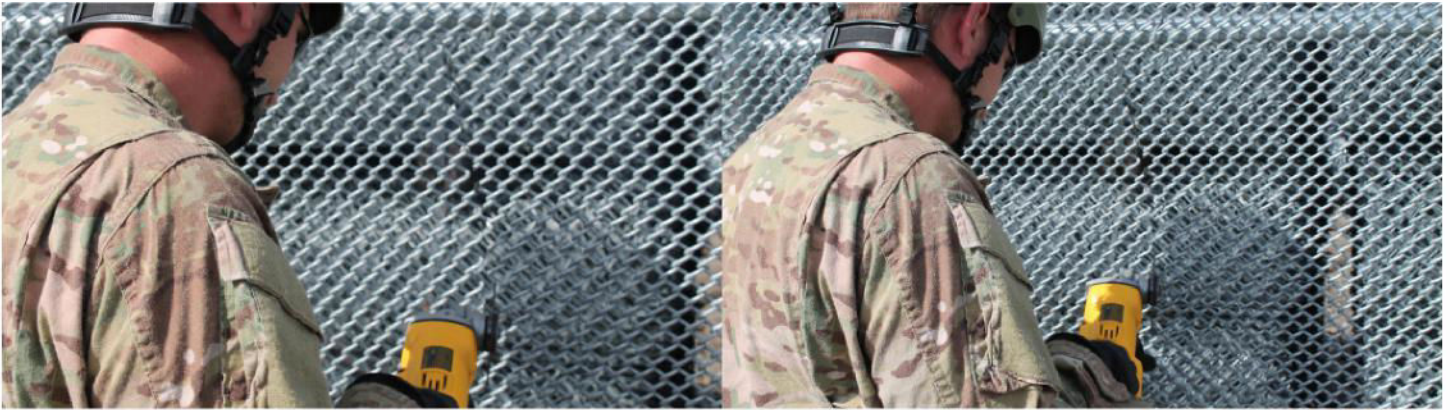
TEST #24

IFI-6 Extreme Cut 6 Gauge 5/8" Weave Chain Link | One person cut-through utilizing 36V battery operated grinder

Description: This test involved one attacker utilizing a battery operated grinder to cut a vertical opening through 6 gauge 5/8" weave chain link fence. The test started when the grinder first touched the fence and ended after the attacker successfully breeched the opening.

Results: Successful penetration in 6 minutes and 1 second.

Issue(s): Grinder produced large amount of highly visible sparks.

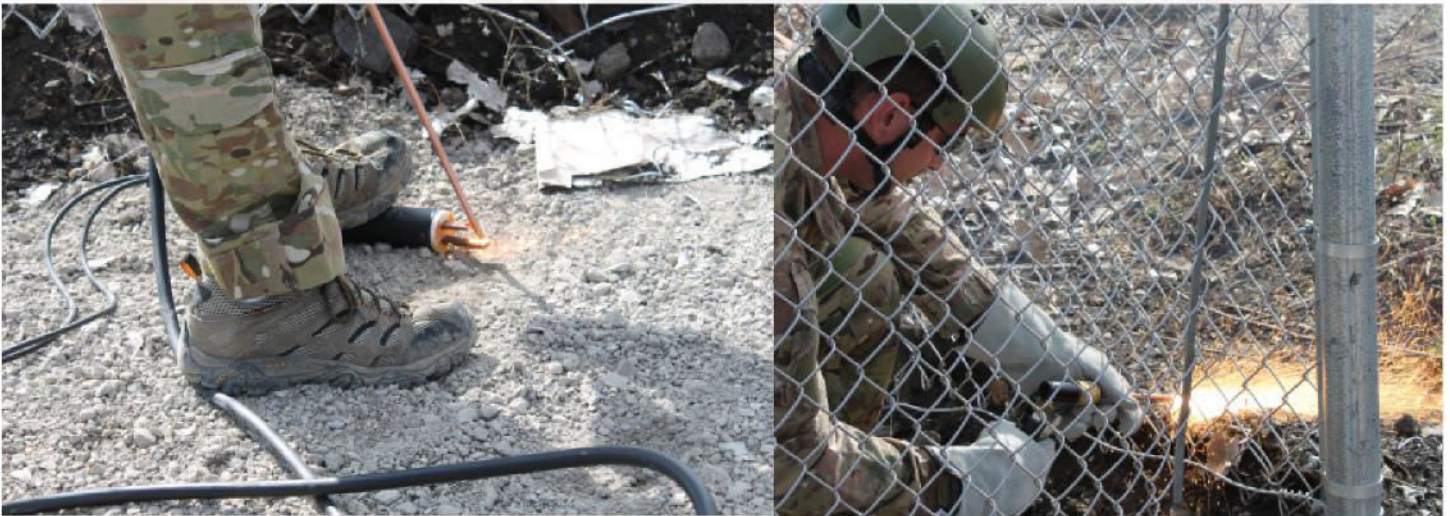
TEST #25

IFI 9 Gauge 3/8" Weave Chain Link | One-person attack utilizing 36V battery operated grinder

Description: This test involved one-person cutting through 9 Gauge 3/8" weave chain link fence. The attacker cut a vertical line large enough to allow passage of a person through the fence. The test started when the grinder first touched the fence, and ended when the attacker was successfully through the opening.

Results: Successful cut-through that took 4 minutes and 8 seconds.

Issue(s): Grinder produced a large amount of highly visible sparks.

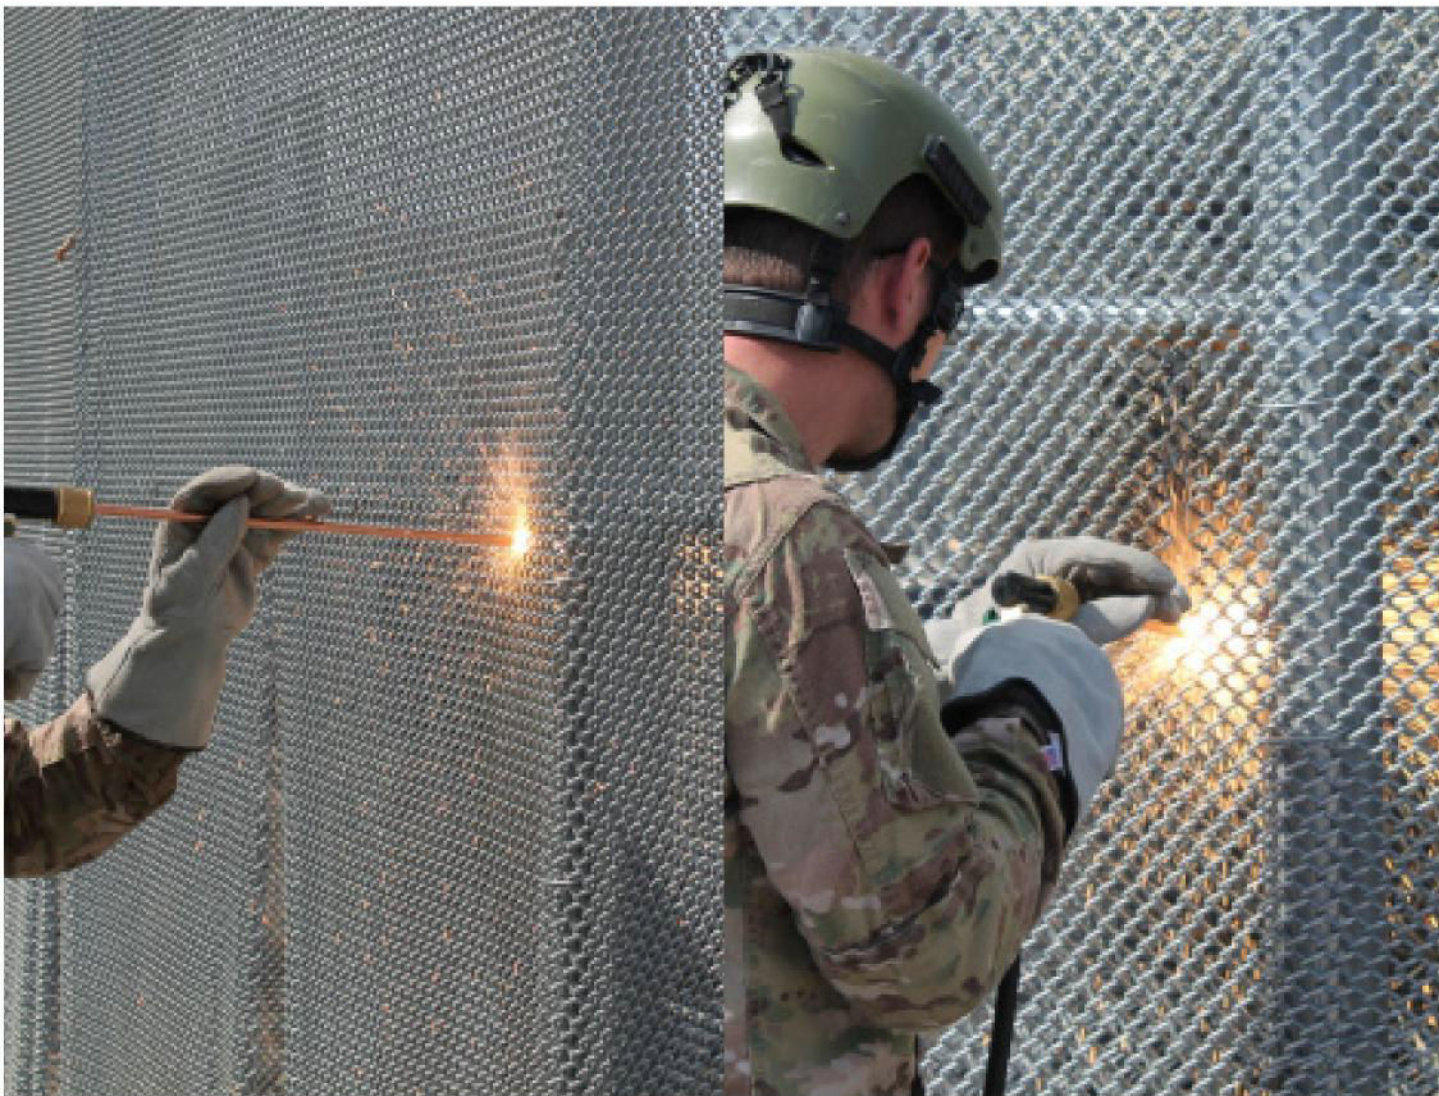
TEST #26

9 Gauge 2" Weave Chain Link | One-person Broco Torch attack

Description: This was a one-person attack utilizing a Broco Torch against a 9 gauge chain link fence. Although this is considered a one-person test, an assistant did provide extra torch rods when spent, and poured water on the fence to cool it after successful penetration. The attacker used the torch to create a vertical opening in the fence. The test started after the torch was lit and ended when the attacker successfully climbed through to the other side.

Results: Successful breach in 1 minute and 26 seconds.

Issue(s): Broco Torch produces a large amount of highly visible sparks and smoke, likely detectable by security cameras or people in proximity to the tool being used.

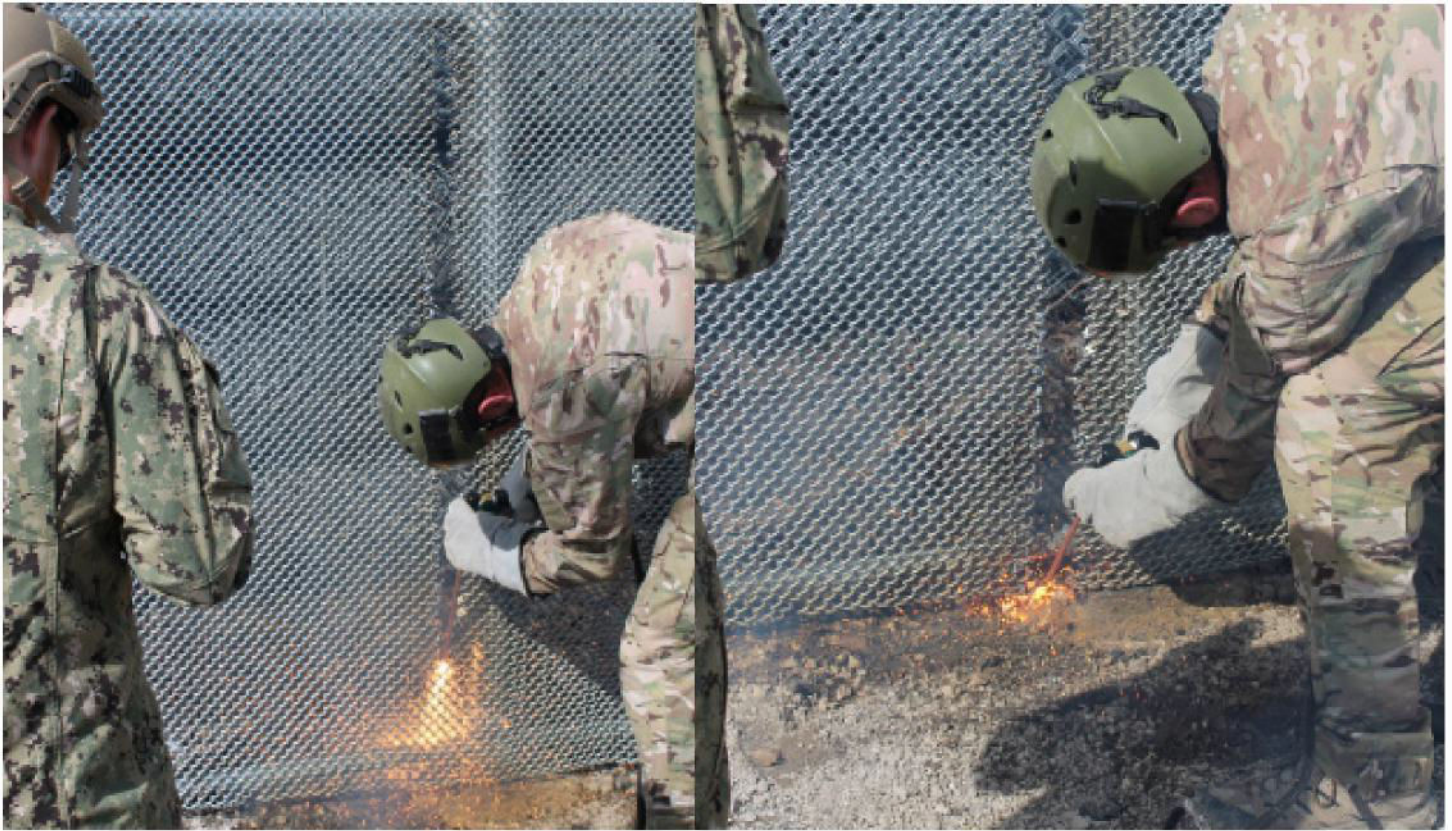
TEST #27

IFI-6 Extreme Cut 6 Gauge 5/8" Weave Chain Link | One-person attack utilizing Broco Torch

Description: This was a one-person attack utilizing a Broco Torch against IFI 6 gauge 5/8" chain link weave. The attacker used the torch to create a vertical opening in the fence, which was then cooled with water before penetration. The test started immediately after the torch was lit and ended when the attacker was successfully through the opening.

Results: Successful breach in 3 minutes and 58 seconds

Issue(s): Broco Torch produces highly visible sparks and gas.
